Analysis of tribological aspects during operation and repair of internal combustion engine valve mechanism parts

Abstract

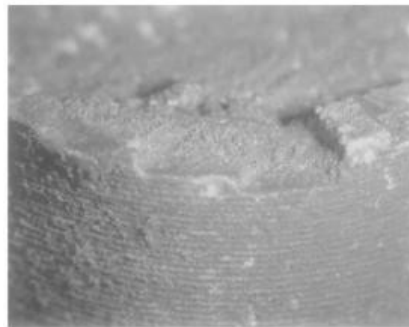
At high loads, multiple cracks are initiated if the valves are exposed to high temperatures, and under these operating conditions it would be logical to expect failure to occur within several million cycles. The broken valve stem is shown in Fig. 1.

Fig. 1. The edge of the fracture surface of the valve stem

Considerable hardness is lost due to overheating and surface oxidation and galling of the valve stem occur. Fatigue properties of the alloy suffer from high temperature. This is the reason for the initiation of multiple fatigue cracks. Faulty exhaust valves are shown in fig. 2.

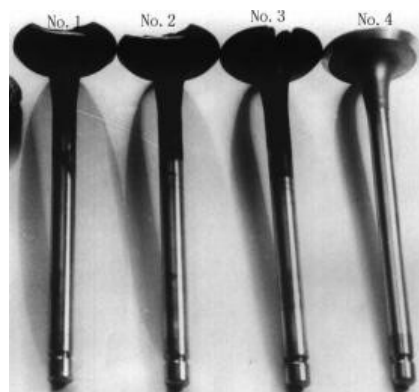
Fig. 2 General appearance of valve damage

It has also been found that wear usually occurs on the valve seat surface and on the stem due to sliding within the stem guide. The rate of wear increases with the number of cycles. Erosion-corrosion failure of exhaust valves is also a recognized failure mode of internal combustion engine valves.

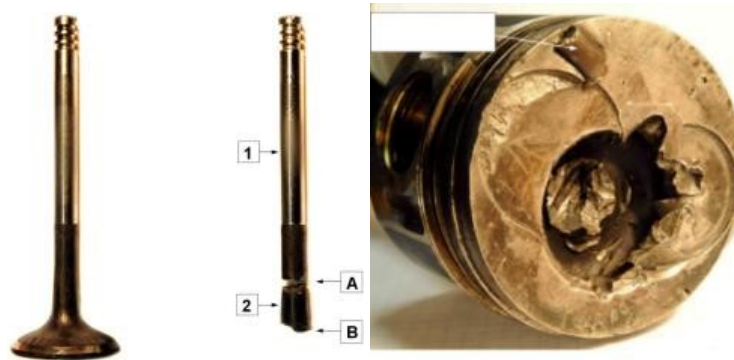
Fig. 3. View of the details of the damaged diesel engine valve

After the breakdown, the engine was disassembled. A piece of the exhaust valve was found in the engine head (part No. 1, Fig. 3). The second piece of the damaged valve (part #2, Fig. 2) was driven into the upper surface of the piston. In fig. 3 shows the depressions formed after the collision of the broken valve head with the piston. The third piece, the damaged valve (head), was lost during the engine repair, so it is not shown. Therefore, the problem of the destruction of the exhaust valve of the diesel engine was investigated. A visual inspection of the damaged valve revealed that fatigue cracks had formed in the valve during engine operation.

An analysis of exhaust valve failures was carried out in [2], diesel engine. A visual inspection of the damaged engine parts showed that the fracture of the exhaust valve showed signs characteristic of fatigue failure. Additional observations of the crack initiation zones showed that the origin of the crack was not covered by material defects or corrosion products. Nonlinear finite element analysis was used to explain the cause of premature valve failure. The results of the stress analysis performed on the soot valve showed that high bending stresses occur in the valve stem.

The car had a diesel engine failure with a mileage of 230,000 km. Damaged 4-cylinder turbocharged piston engine, fatigue failures of exhaust valves in this engine occurred at significantly higher mileage (600-900 thousand km).

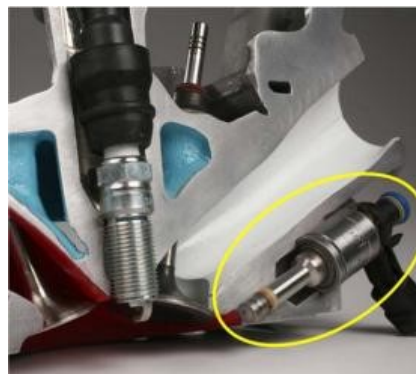
Since the fuel is injected directly into the combustion chamber and not into the intake valve like in PFI engines, there is no longer the washing action of the fuel and the cleaning additives contained in the fuel to keep the intake valves free of deposits. Possible intake valve deposits now build up steadily over time until they affect engine performance, often with disastrous results. In fig. 4 shows the direct fuel injection system with the position of the fuel injector relative to the intake valve.

Fig. 4. Direct fuel injection system

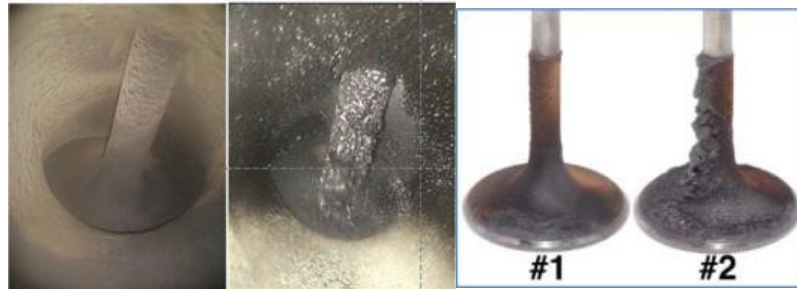
Due to the lack of a fuel flushing process, characteristic of engines with port fuel injection, deposits constantly accumulate over time and can lead to poor combustion, unstable operation, valve sticking or engine failure (Fig. 5). Vehicles using these engines often have to undergo expensive maintenance to mechanically remove the deposits that reform over time. On a car equipped with a 2.0-liter GDI turbo engine, the mechanisms leading to the formation of deposits were studied and analyzed. It has been determined to be a combination of engine oil, engine wear, unburned fuel and exhaust pollutants. It was also found that the rate of accumulation is affected by the composition variables of the motor lubricant.

Fig. 5. Deposits on intake valves

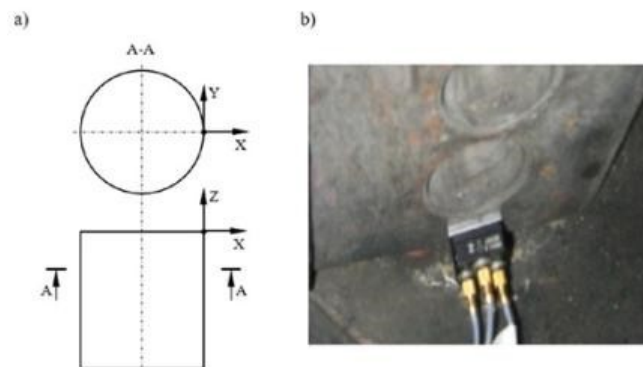
Fig. 6. a) Orientation of vibration measurement directions on the cylinder head, b) view of the vibration sensor installed on the cylinder head

The selection of the vibration measurement point (Fig. 6) was preceded by an analysis of the design of the cylinder head, studies related to the determination of the influence of the valve clearance of the diesel engine on the selected vibration parameters. The received vibration signal was parameterized for the engine operating under different engine loads, rotation frequency and valve clearance settings. The parameterization concerned the characteristics of vibration signals, the derivative of the vibration signal as a function of time, as well as the envelope of this derivative. Based on the conducted research and analysis, a methodology for assessing the valve gap is proposed.

The dynamic development of the design of internal combustion engines creates the need to introduce operation strategies based on information about their technical condition. The article [4] analyzed the problems associated with the vibration diagnosis of the valve gap of the internal combustion piston engine, which is significant from the point of view of efficiency and durability. Classification methods are proposed for evaluating valve clearance. Experiments aimed at providing information necessary for the development and verification of the proposed methods were performed and described. In the conducted studies, vibration signals were obtained from a triaxial accelerometer located in the head of the engine cylinder block.

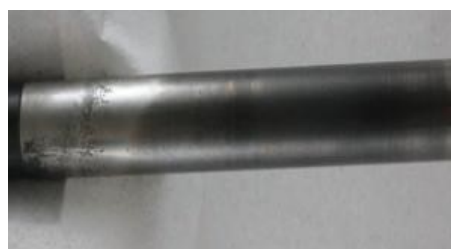
The article [6] presents an analysis of elements of internal combustion piston engines that interact with the combustion chamber. An assessment of the state of tribological nodes: valve stem - valve guide and valve head - valve seat in random operating conditions was carried out. The image of wear and damage of parts of tribological nodes was studied (Fig. 7).

Fig. 7. Pathological wear of the guide part of the intake valve stem from the head side

Analysis of digital images of real objects was carried out using an optical microscope and measurement of macro- and microgeometry. Identification of the main wear processes was carried out.

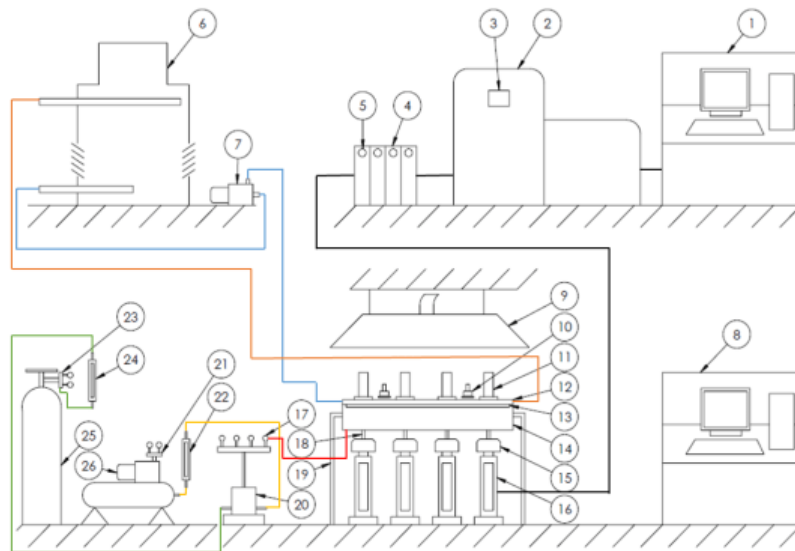
In the article [7], he proposed a multifunctional device for determining wear for the study of tribological characteristics of connections of the valve mechanism of the engine (Fig. 8). The device uses a mechanical load system, which consists of a special eccentric wheel and disk springs that simulate the load from the engine combustion chamber, as well as simulate the contact loads of the valve mechanism elements. The test bench has three functions for different studies using specially designed instruments. The first function aims to evaluate the interaction between the valve seat surface and the seat insert at high temperatures and loads. The second function is used to investigate the friction and wear properties of the valve stem and valve guide. The third function is designed to evaluate the performance of valve seals. Tests were conducted using the proposed experimental complex. It was established that the wear mechanisms occurring in the studied friction pairs are a combination of oxidative wear, adhesive wear, and fatigue delamination.

Fig. 8. Experimental complex of tests of friction pairs of the internal combustion engine valve mechanism: 1 - hydraulic control system, 2 - hydraulic pump, 3 - hydraulic control panel, 4 - oil pressure in the hydraulic accumulator system, 5 - pressure indicator, 7 - pump cooling system, 9 - exhaust system, 10-rotor valve, 15- strain gauges, 16- hydraulic drives, 19- stand for testing holders, 20- gas mixer, 25- cylinder, 26- compressor

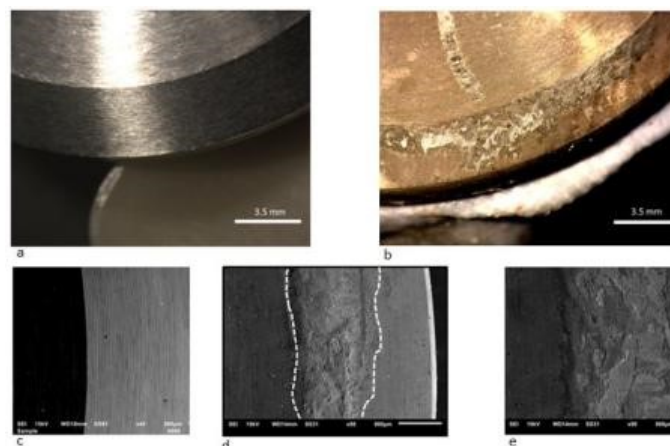
In fig. 9 shows the results of SEM analysis on the valve surface. After the tests, no signs of cracks or corrosion pits were observed. Quantitative analysis using energy dispersive spectroscopy (EDS) was performed on different areas of the valve surface.

Fig. 9. Microscopic analysis of the valve surface before and after the tests

As a result of repeated loads and high temperature, the valve seat material became detached and adhered to the valve surface. This was confirmed by microscopy when additional material was observed attached to the valve surface (Figures 9a and 9b). A stellite coating was preserved on some parts of the valve surface (Figs. 9d and 9e).

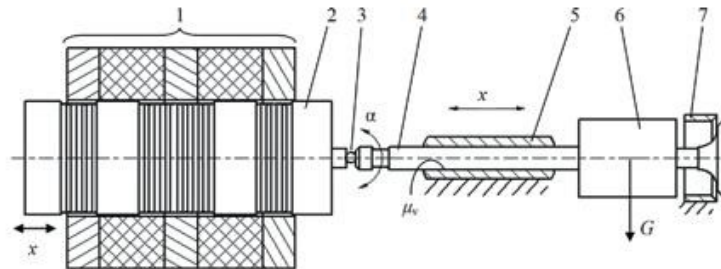
Fig. 10. Unit model: 1 – fixed part of the drive, 2 – moving coil, 3 – hinge, 4 – valve, 5 – guide, 6 – additional load, 7 – seat insert

A model of the unit was developed (Fig. 10), which consisted of valve 4 and a moving coil 2 of the actuator and is presented in Fig. 3. The displacement x of such a coil parallel to the axis of the stationary part 1 of the drive was assumed to be equal to the displacement of the valve obtained during its measurement in the tester. Such displacement is limited by the settlement of the seat insert 7. The valve is loaded with an additional weight 6, which causes a force G , perpendicular to the axis of the guide 5. The valve can also wobble by an angle α , within the limits limited by the gap between the valve stem 4 and its guide 5. Such wobble is allowed due to the presence of a spherical joint 3. The studied valve was set in electromagnetic motion for different strokes and frequencies of the valve. Contact took place in the absence of oil. The valve was loaded with additional mass to create a normal force between the valve stem and its guide. The acceleration and displacement of the valve, the impact force of the valve on the seat insert, the friction force between the valve stem and its guide and the sound level were measured. The purpose of the research is to obtain and compare the values of the coefficient of friction between the cast iron guide and the Ti6Al4V valve stem for a certain number of valve strokes and frequency. The leg under study can be bare or covered with a layer of Cr or nitriding. An analytical model was developed to calculate the contact pressure and friction force between the valve stem and its guide for the mixed friction conditions that occur for the selected engine oil and the movement of the valve relative to its guide.

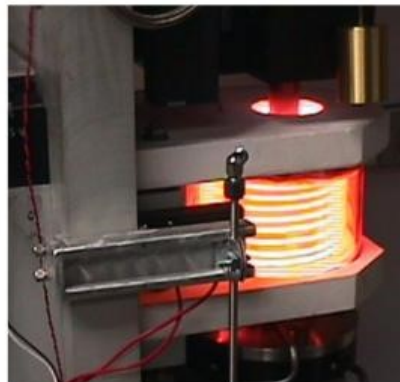
In work [171], experiments were conducted using a high-temperature tribological test system (Fig. 11). For this experiment, an exhaust valve made of a nickel-based alloy called Pyromet was machined into a flat disc, and a sample pin was made of a Co-based alloy (Stellite). The pin had a spherical end with an initial radius of 9.53 mm and the test was carried out under a normal force of 1710 N at a sliding speed of 0.1 m/s. Sliding was performed for 60 seconds at each of the following temperatures: 450, 550, 650, 750, 800, 850 o C.

Fig. 11. High-temperature sliding friction and wear test system.

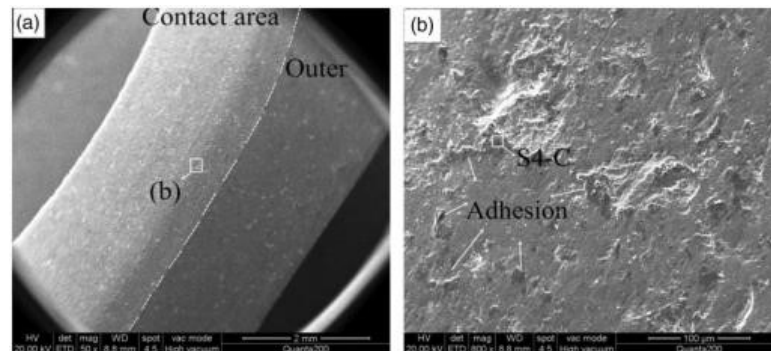
bench tests of traditional steel valves and TiAl valves were conducted using a specially designed apparatus for testing wear. Compared to traditional valves made of heat-resistant steel (X60, X85), TiAl valves have 50% less weight, which leads to a decrease in resistance during engine operation. By reducing the inertia of the engine valve movement, the dynamic characteristics of the engine valvetrain system can be optimized. Each contact pair of the valve and seat insert has been tested for 3 million impact cycles. Compared with the austenitic exhaust valves (X60) tested at 700°C, the TiAl valve had better wear resistance and the wear loss was reduced by 24.8%. The dominant wear mechanism is considered to be a combination of oxidative wear and adhesive wear. However, for the intake valves tested at 400°C, the wear loss of the TiAl valve was three times higher than the martensitic intake valves (X85). The predominant wear mechanism can be defined as abrasive wear and adhesive wear (Fig. 12).

Fig. 12. (a) Worn surfaces of valve seat insert; (b) magnified image of worn surfaces and EDS S4-C test area.

Thus, it is concluded that the TiAl exhaust valve is a potential solution for a diesel engine running on natural gas.

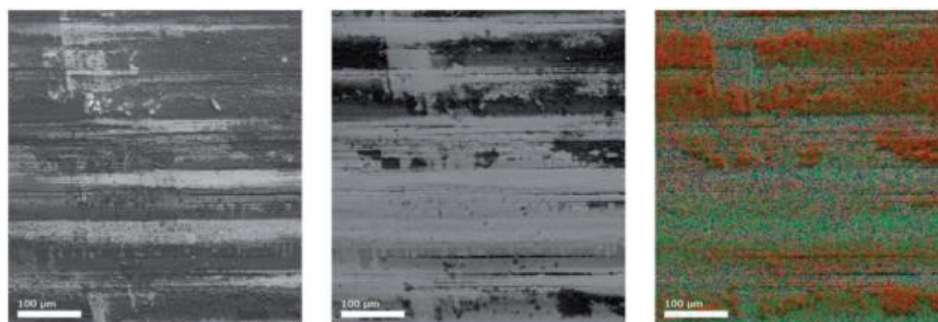
One way to combat random behavior may be to promote the reliable operation of protective tribofilms by texturing valve seal surfaces to improve grease capture and storage [20]. At the same time, depressions perpendicular to the slip are created (Fig. 13).

Fig. 13. Appearance of the textured surface of the valve after 100,000 cycles.

The number and localization of tribofilms became more stable than without texture, which led to a decrease in surface wear. For the same width, deeper depressions showed less delamination of the tribofilm.

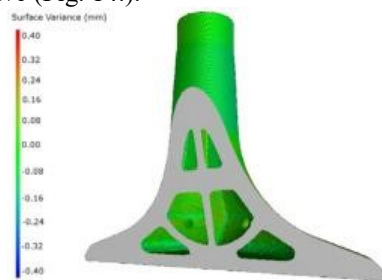
The production of additive layers of metal components provides significant opportunities to reduce the weight of parts in order to increase the fuel efficiency or performance of the vehicle. In the article [23], filling materials are considered to reduce the weight of intake or exhaust valves of an internal combustion engine. Micro-computed tomography (μ -CT) was used to reverse engineer the original component and assess the internal geometry and material integrity of the valve (Fig. 14.).

Fig. 14. Results of valve design analysis

The valve has been redesigned using Finite Element Analysis (FEA) to select a lightweight weighted design that provides a weight savings of 9.4g (20%) compared to the original equipment valve. The engine was tested for more than 175,000 cycles at 2,000 to 9,500 rpm, after which μ -computed tomography confirmed no signs of internal cracking, failure, or significant deformation.

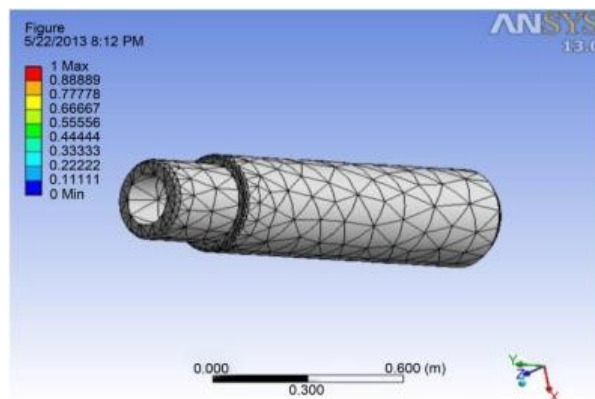
In [27], engine reliability was improved using Al-Sic composites for engine guide valves. Aluminum matrix composites turned out to be the most suitable for the automotive industry. Finite element analysis of Al-Sic composite with titanium alloy (Ti-834), copper-nickel silicon alloys (CuNi3Si) and aluminum bronze alloy as alternative engine valve guide material was performed using Ansys 13.0 software. The finite element method is one of the most widely used methods for analyzing mechanical load characteristics in modern engineering components. The directional valve model was modeled as shown in Fig. 15. A finite element model was built to analyze the guide valve.

Fig. 15. Finite element model of the valve stem-guide bush connection

The stress analysis of the engine valve guide at different pressures and temperatures was carried out. The pressure is taken from 10 MPa to 100 MPa with different temperatures from 600°C to 650°C. It was found that the stresses were significantly lower than the allowable for all materials, but Al-Sic composites were found to be the most optimal.

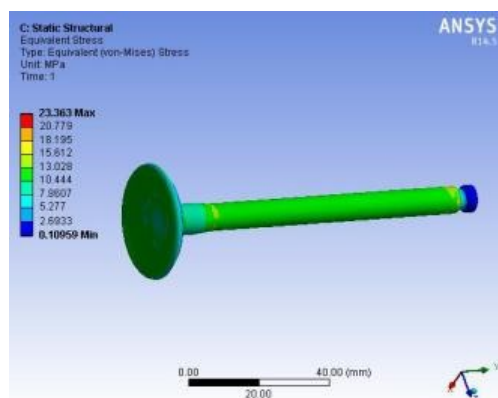
Static and thermal analysis was performed on the valve (Fig. 16) by changing two materials at 5000 cycles.

Fig. 16. Static analysis of the valve mechanism
