Wear resistance and lubricity of the spiral oil distribution profile of the valve guide sleeves of an internal combustion engine

O.V. Dykha^{*}, A.A. Vychavka, M.O. Dykha

Khmelnytskyi national University, Ukraine

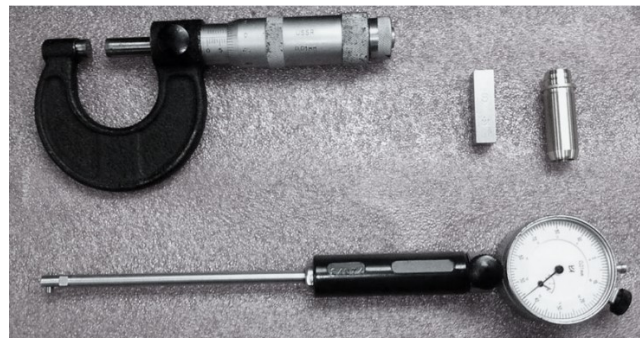
Defecting guide bushings is a necessary condition for high-quality repair of the cylinder head. Due to the small hole, there are certain difficulties in controlling the dimensions of worn bushings. Defection of the bushings is carried out with the help of calipers or gauges (Fig. 2).

Fig. 2. Tool for measuring valve bushings.

The feeler gauge and cylindrical calipers allow for defecting of guide bushings with an accuracy of 0.01 mm. A micrometer is used to measure the valve stem. Measurements of the valve are necessary to determine the "sleeve-valve" gap.

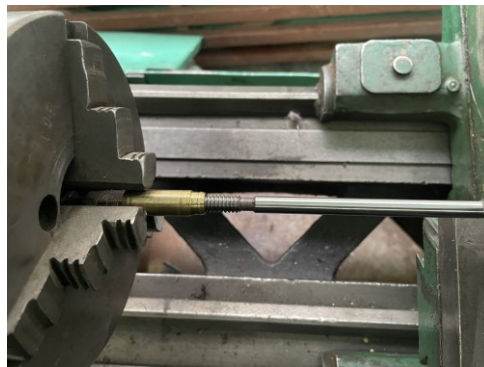
The guides were processed on a lathe (Fig. 4). The sleeve was centered and fixed in the cam cartridge and rotated. The tool carried out a progressive axial feed movement.

Fig. 4. Treatment of the oil-retaining profile of the valve guide sleeve

After applying this technology, a spiral oil retaining profile remains on the surface of the sleeve opening, which:

- increases the oil capacity of the surface, and therefore improves the lubrication conditions in the "valve-guide" friction pair;
- a gas-labyrinth seal is created in the connection, which prevents oil from entering the combustion chamber;
- the surface of the sleeve opening is strengthened due to surface compaction (slender effect).

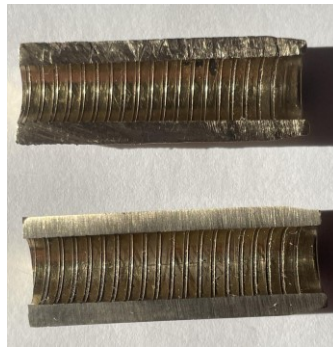
In fig. 5 shows the profile of the spiral oil retention grooves formed on the inner surface of the valve guide sleeve. The profile of the grooves, in accordance with the design of the tool, had a rounded shape.

Fig. 5. Spiral oil retaining grooves of the valve guide sleeve

In the process of plastic processing of the oil-retaining grooves in the opening of the guide bushing, the surface layer of the working surfaces is defamed, which also contributes to increasing the wear resistance of the bushings with grooves.
