## **Analysis of the causes of damage to centrifugal pumps during operation and methods of their elimination**

**I.V. Morshch**

*Kyiv Aviation Institute, Ukraine*

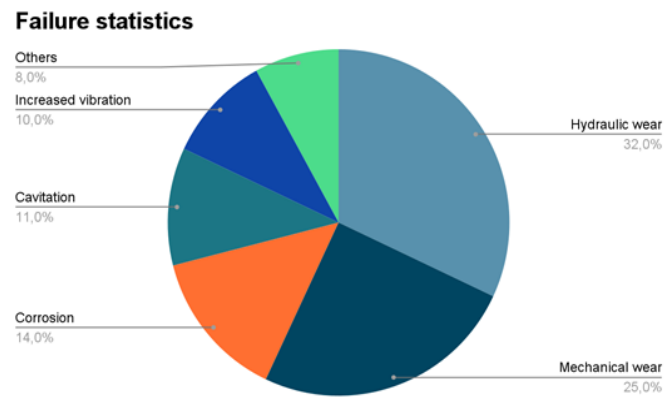
- hydraulic wear (32%): impeller (blade wear, corrosion, cavitation), body (wear of the inner surface, corrosion);
- mechanical wear (25%): bearings (wear and tear, breakage), seals (wear and tear, loss of tightness), shaft (wear, bending, breakage);

**Fig 1. Statistical data on the failure of centrifugal pumps.**

- corrosion (14%): all parts (corrosion can affect any part of the pump, especially in aggressive environments);
- cavitation (11%): impeller (cavitation causes the surface of the blades to be destroyed);
- increased vibration (10%): rotor imbalance, damage to the bearings, loosening of fasteners, hydraulic imbalance.
- other reasons (8%): installation errors, damage by foreign objects.

According to statistical data in [5,6], the failure rate of centrifugal pump parts is indicated, the bulk of which falls on (Fig 1):

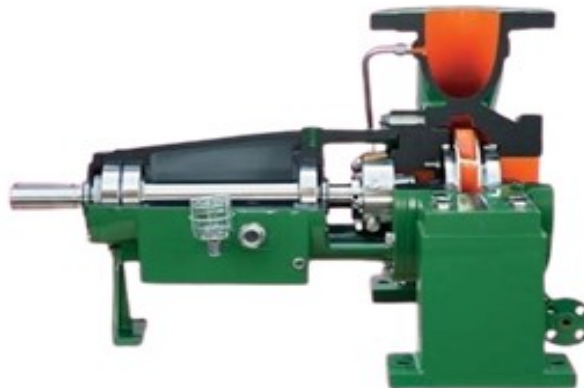
**Fig 2. Dickow Pumpen NCR 125/320 centrifugal pumps**

The Dickow NCR pump is a heavy duty centrifugal pump for the oil, petrochemical and gas industries, manufactured in accordance with API 610 standards. Available in a wide range of sizes and specifications, it has a maximum flow rate of up to 700 m<sup>3</sup>/h and a maximum head of 145 m at 2900 rpm and 220 m at 3500 rpm.

The object of the study was a Dickow Pumpen 125/320 centrifugal pump for the transportation of fuels and lubricants (Fig 2). This type of pump was used in the company's pile-lubricant warehouse.

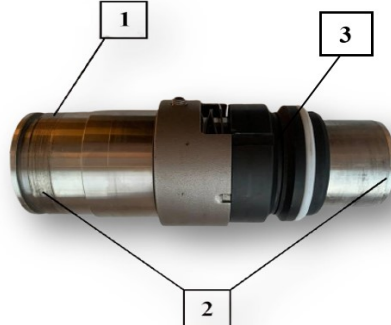
**Fig 3. Dickow Pumpen mechanical seal part, operating time 6500 hours: 1 – abrasive wear of mechanical seal components; 2 – fretting corrosion due to friction and operation in aggressive environments; 3 – after abrasive wear, additional vibrations were generated on the mechanical seal part, and the graphite rings began to break down.**

After 6500 hours of operation of the pump unit, significant wear of the mechanical seal was detected, which manifested itself in the form of abrasive damage and traces of fretting corrosion. These defects were caused by prolonged operation in an aggressive environment (kerosene) and constant exposure to mechanical and chemical factors. The first signs of damage were leakage of working fluid and abnormal noise during pump operation, which indicated a violation of the seal tightness. In order to prevent further malfunctions, the pump was shut down for diagnostics and inspection. As a result, it was decided to replace the damaged seal to restore normal operation of the pump. Based on the experience gained, it is now possible to implement technical solutions that will extend the mechanical seal's service life. Therefore, a lot of research is currently focused on analyzing and finding relevant solutions to improve the performance of centrifugal pumps. In particular, experimental work is carried out under unstable conditions at partial load, and the results at different operating points are compared with available experimental data, such as hydraulic performance and flow field information by measuring the particle image velocity [8,9].

The pump is operated in an aggressive environment (kerosene) with an average operating time of 6 hours per day with interruptions. The total continuous service life was 3 years. The shaft, bearings, and mechanical seal are subject to the highest loads, with the mechanical seal experiencing the most significant wear (Fig 3).
